Why Does Your Building Leak???

Part II: Aircraft Hangars: The Conceptual Design and Selection Process

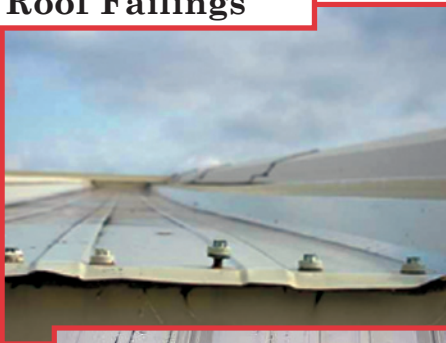
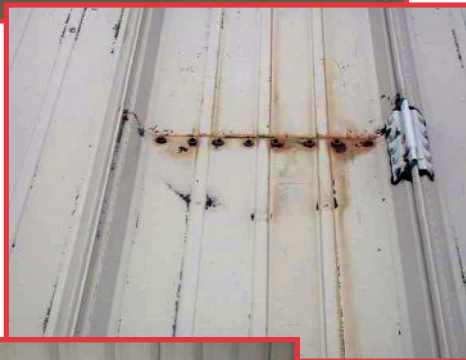
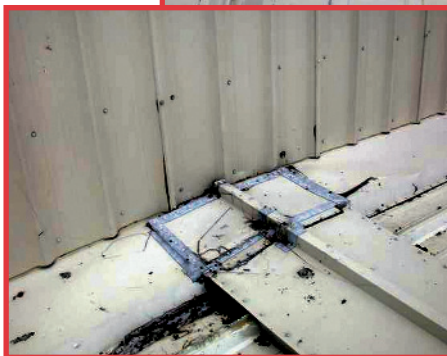
Examples of Metal Roof Failings

These "standardized" structures are not usually engineered to undergo the large seasonal temperature variations. These variations lead to large thermal expansion and contraction stresses in the continuous frame and purlins. The resulting large movements can inadvertently stress the metal standing seam roof beyond its movement capacity and the result is a big leak. Beware of unheated construction!
